CIVIC HOUSE RETROFIT

Civic House, originally constructed in 1920 as a printing press, is now a workspace, venue and canteen that supports a community of people working across social, cultural and green enterprise. Collective Architecture was commissioned by Agile City to undertake the refurbishment and thermal upgrade of the early 20th century industrial warehouse located in the north of Glasgow.

The core principle of the project is to create a leading example that demonstrates carbon reduction innovation as Scotland's first retrofit 'PassivWareHaus'.

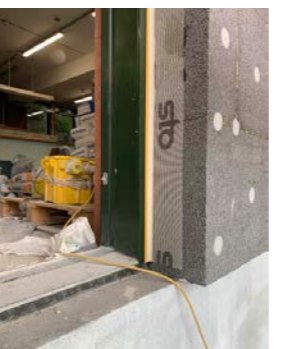
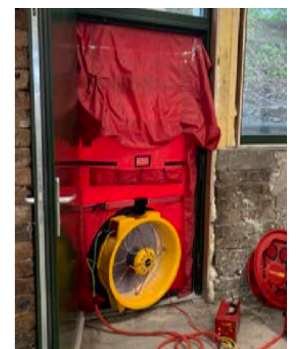
04.EXTERNAL WALL INSULATION, AIRTIGHTNESS STRATEGY AND HEAT RECOVERY SYSTEM

Phase 2 scope of works include installation of the 50kW PV roof array in March 2020 with completion of external fabric efficiency works (airtightness/ insulation), installation of high-performance windows and doors and Mechanical Ventilation with Heat Recovery (MVHR). Wider list of works by Agile City are installation of Air Source Heat Pump (ASHP), upgrade the T8 fluorescent lighting to energy efficient LEDs which will be further enhanced by the installation of motion sensors throughout, installation of aerated taps to reduce the volume of water produced throughout the building and installation of WIFI enabled thermostat controls to create controllable zones that respond to different types and volume of use throughout the different spaces.

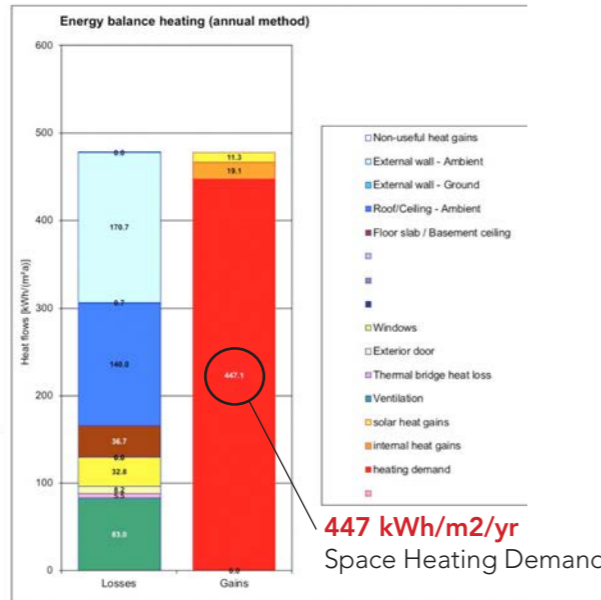
EXISTING ANNUAL HEATING DEMAND

To maintain the building at a comfortable 20°C throughout the year. The estimated space heating demand would be around 450kWh/m²/a. Utilising existing mains gas as primary fuel source at 4p per kWh would equate to £13230 per year heating cost.

- U-value
- External walls - 2.46 W/m²K
- Roof - 2.87 W/m²K
- Windows - Installed 1.8W/m²K*
- Doors - Installed 3.0 W/m²K*
- Air tightness - 7.0 ACH@50Pa

Naturally ventilated

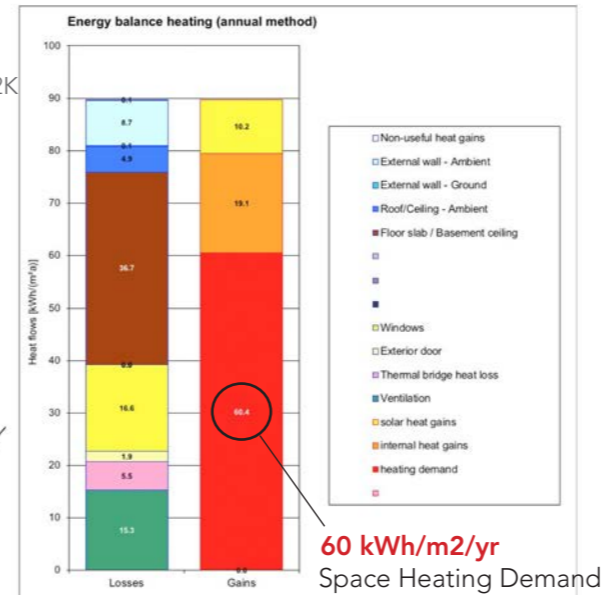
PROPOSED ANNUAL HEATING DEMAND

By utilising a fabric first approach it is possible to reduce the heating demand by around 90%. The current proposal has a space heating demand of 60kWh/m²/a. Utilising existing mains gas as primary fuel source at 4p per kWh would equate to £1764 per year heating cost. This is without insulating the ground floor.

87%
Reduction in space heating demand

- U-value
- External walls - 0.12 W/m²K
- Roof - 0.1 W/m²K
- Windows and Doors - Installed 0.9 W/m²K
- Air tightness - 1.0 ACH@50Pa

MVHR- Efficiency approx. 80%

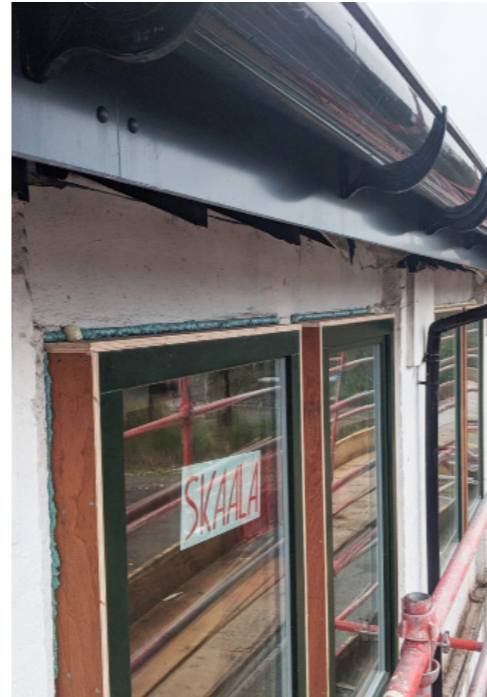
STEP 4

DEFINE THERMAL ENVELOPE, WORKING ON THERMAL BRIDGE AND AIRTIGHTNESS DETAILS

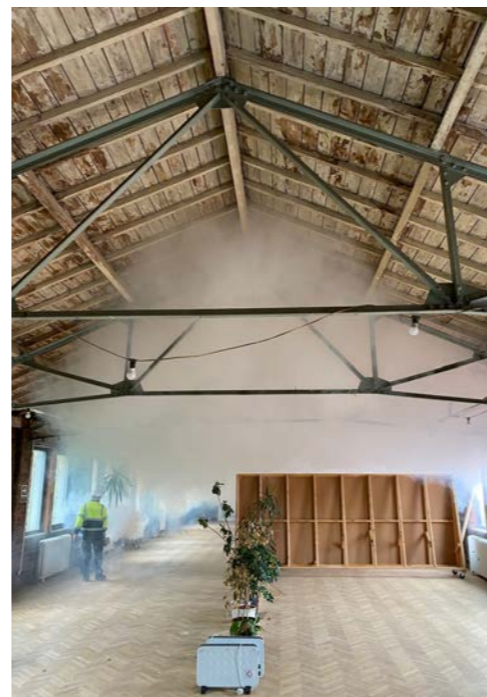
STEP 5

INTERIM AIRTIGHTNESS TEST & SMOKE TEST (April 2021)

The roof works have been completed in 2019. The installation of windows completed in January 2021 and the EWI is to follow in February 2021. At the time, we thought it would be a good opportunity to undertake a fault finding airtest. This precedes the EWI works intentionally as we would like to investigate the permeability of the external walls if at all possible.

The building is pressurised to 60-70 Pascals, and fill it with smoke internally, and video leakage points from the outside. As smoke will travel through the easiest points, by careful set-up and monitoring, we could determine qualitatively if there was significant leakage through the mortar joints or other aspects of the wall.
